FIELD INSPECTION

Project Name: Mountain Valley Pipeline Date: Tuesday, January 29, 2019

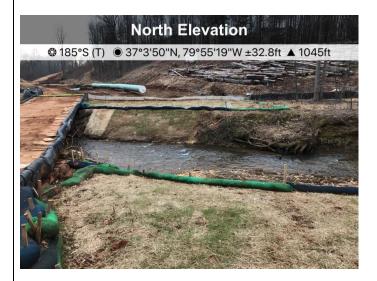
Fig. 2 Controls in place and functioning at designated stream S-C14

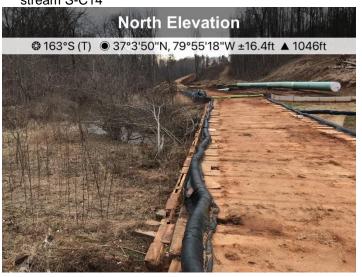
Fig. 3 Controls in place and functioning at designated stream S-C14
